P00\_3 / 14.11.2021

Stairs and floor flatness / 05.11.2021

## Facilities 2 / 20.09.2021

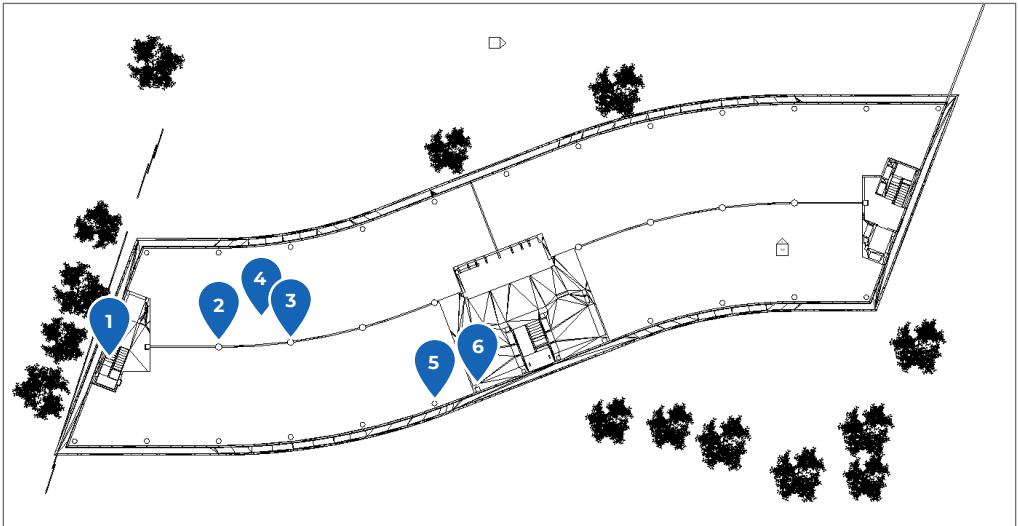
## Detected deviations (6)

| # | 1 | 2 | 3 | 4 | 5 | 6 |
| ID | P2_0013 | P2_0086 | P2_0016 | P2_0030 | P2_0031 | P2_0032 |
| Type | IfcStair | IfcFloor | IfcColumn | IfcColumn | IfcColumn | IfcColumn |
| % of Similarity | 91.8 % | 63,7 % | 95 % | 58,3 % | 99.8 % | 78.2 % |

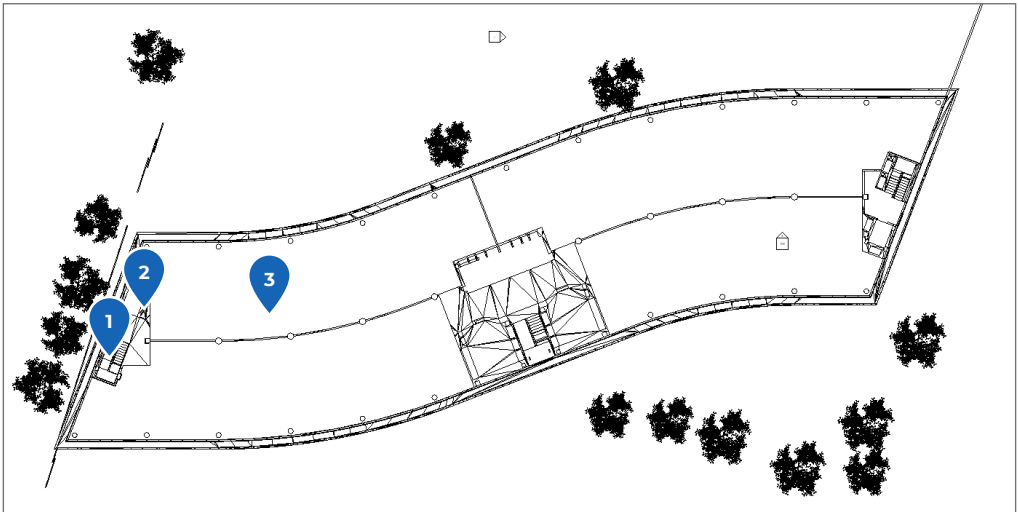
Detected deviations (3)

| # | 1 | 2 | 3 |
| ID | P2_0013 | P2_0014 | P2_0086 |
| Type | IfcStair | IfcStair | IfcFloor |
| % of Similarity | 78.9 % | 89 % | 63,7 % |

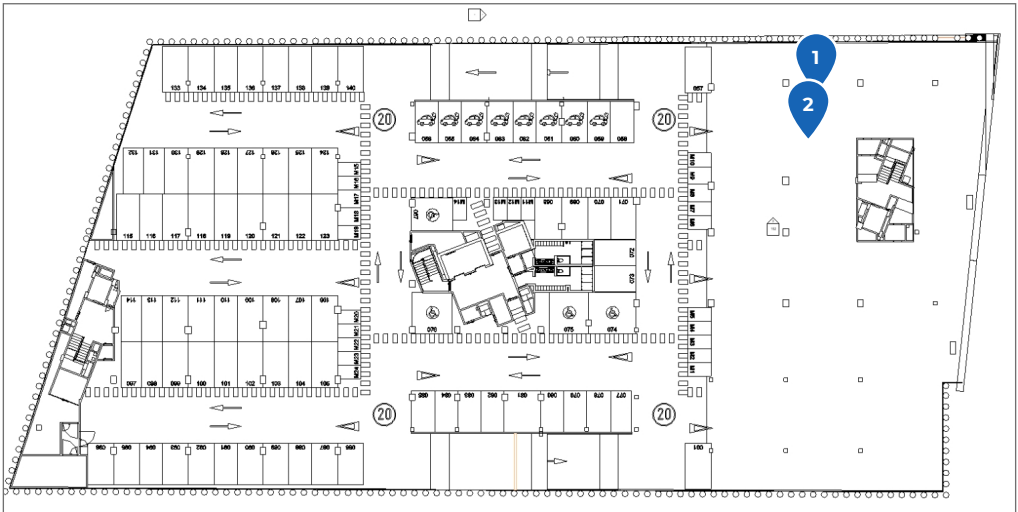
### Detected deviations (2)

| # | 1 | 2 |
| ID | P1_0103 | P1_0105 |
| Type | IfcElectric Distribution Board | IfcElectric Distribution Board |
| % of Similarity | 89,7 % | 86,1 % |
