About the project:

- Location: Madrid, Spain.
- Industry: Office building

The problem

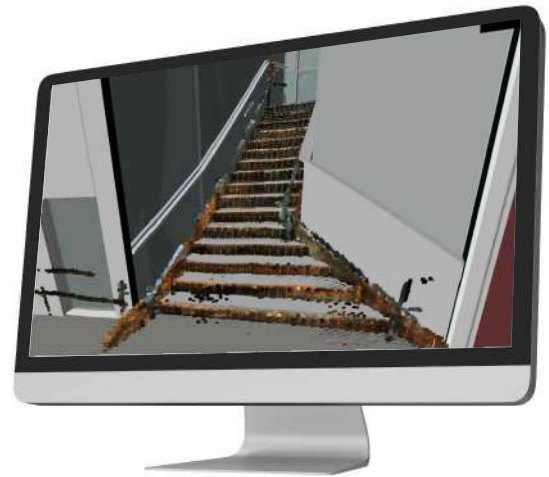
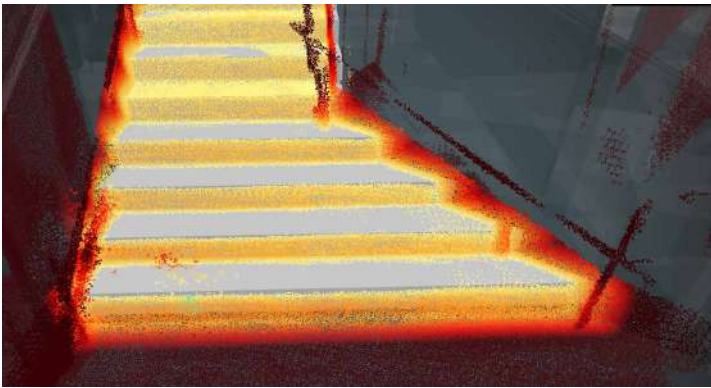
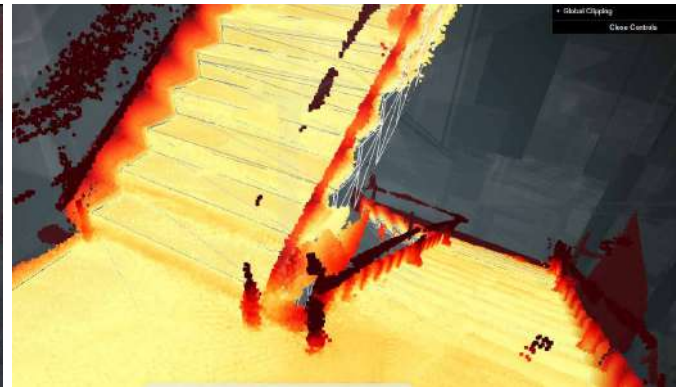
1st INSPECTION RESULTS

The first inspection was executed on the stairs in the central access tower of the project, between the first and second floor. At the moment of the operation the element’s concrete wasn’t completely poured. Thus, the system was able to confirm the formwork alignment on the constructed element and the remaining part to pour.

The system has made a very good comparison of the stairs in formwork, without having finished pouring all the concrete. Actually, it is evident that the edges of the steps are detected as being part of the formwork and not the model, but the already poured concrete is perfectly flat

Something similar happens around the side corners of the stairs, where we can observe that the biggest difference between the point cloud and model is in the protruding formwork elements, nevertheless the percentage estimated to be inside of tolerance (which we call “Similarity Percentage”) is of around 97%

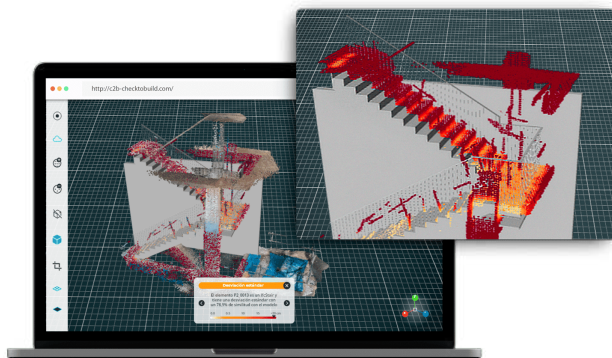
2nd INSPECTION RESULTS

C2B Platform aligned, self-corrected and cleaned the as-built model to automatically provide results 34h faster than the traditional methods.

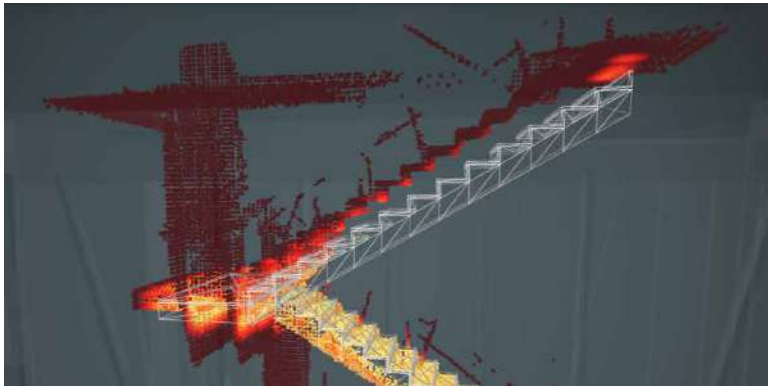
The second section of the stair has a higher inclination than that of the model. Its most distant area would represent an extra cost of 40.28ft³ of concrete

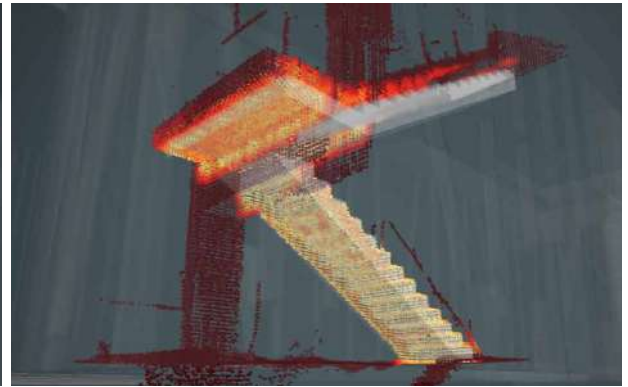
The element has 61% of similarity (points inside our tolerance values) with the projected element in the model

Since in the two inspections of similar elements, the use of formwork was necessary, it was concluded that in the case of the second inspection, when the operation was carried out after the pouring, deviations were incurred in the concrete that could have been corrected in advance. As verified in the first inspection case; where the inspection was carried out on the formwork and only 70% of the concrete had been poured, That, allowed the team to verify the correct alignment of the formwork to the model.
