About the project:

- Location: Madrid, Spain.
- Industry: Office building

The problem

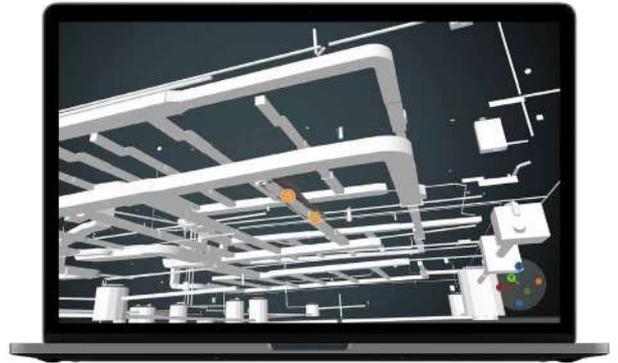
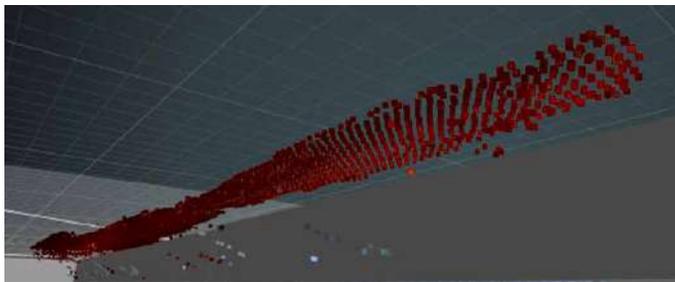
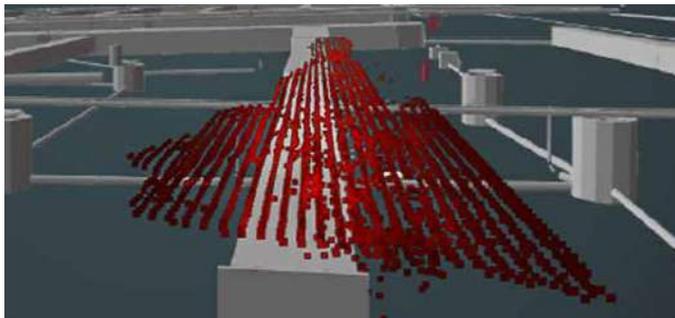
- The inspection was performed by the site manager, and the system found the **item just 5% within tolerance** of the model. Thus, all the point cloud is in red representing the installed element distance from the model
- The alignment of the water pipes inspected has been confirmed **8 time faster** than in traditional review methods
- The pipe is 10.05 ft tall, **3 in outside the tolerance** of the planned element

The client verified all the water facilities of the plant under construction, the general result was good, finding a single element out of tolerance. Even so, the deviated pipe was higher than it should have been (9,8 ft high), and this not only implied extra costs of qualified personnel, said error also implies extra hours for the architect to update the BIM model.
