- Location: Madrid, Spain.
- Industry: Office building- Work phase: Above Ground - Structure
- Data capture method: iPad Pro (Sitescape)- Size: 232737.27 ft²
- Project value: \$16.5M

The problem

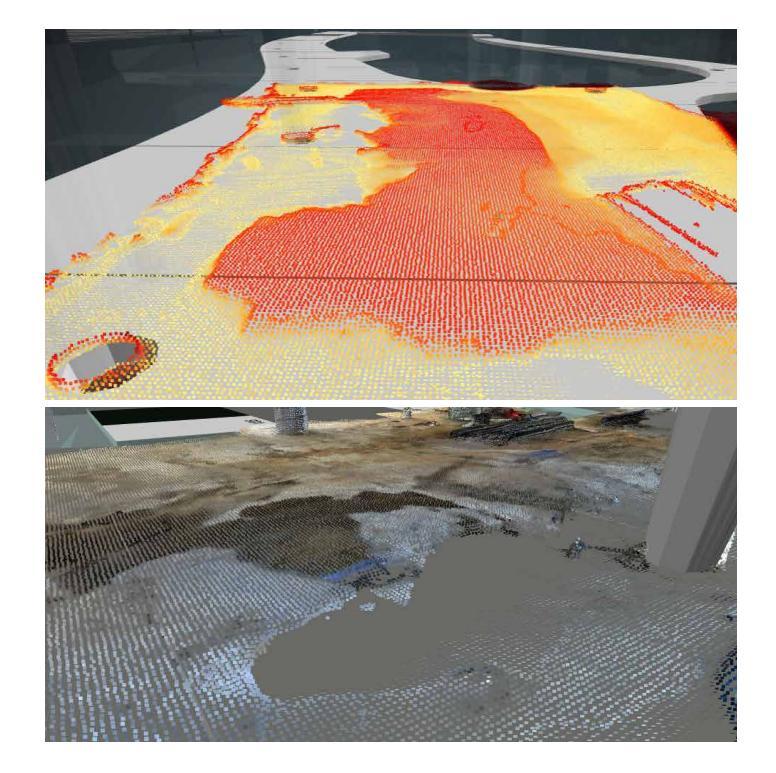
Upon quick inspection through the c2b platform it was clear that there was a discrepancy in several areas. But the most critical deviation was observed in the flatness of the floor:

- An area of **30ft² is uneven** and causes accumulation of water
- The deviated area has only 54% inside planned tolerance
- The responsible obtained **results 90% faster** to make decisions
