About the project:

- Location: Madrid, Spain.
- Industry: Office building

The problem

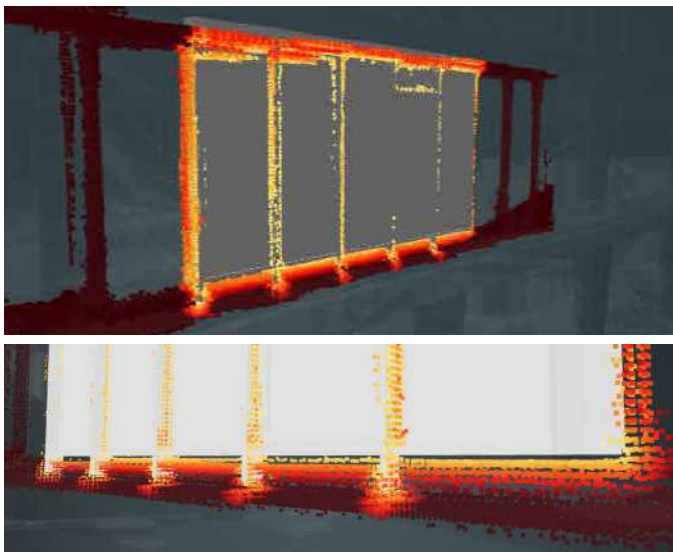
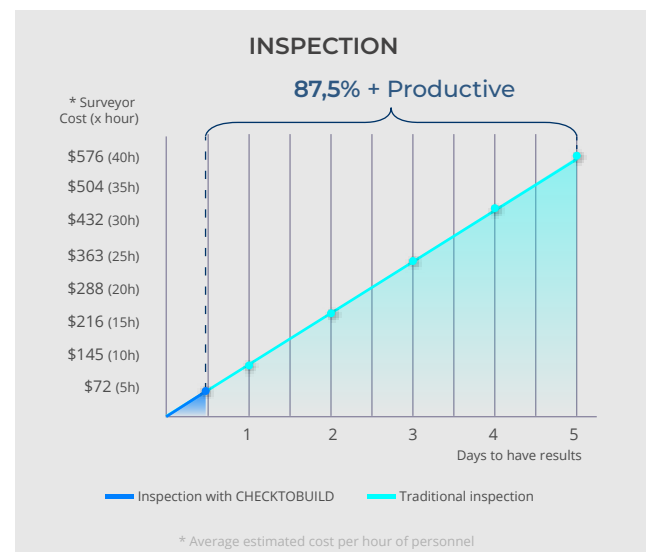
As the most suitable data capture technique for the client was through applications on an iPad, the inspection was processed with more than one point cloud against the BIM model, it showed:

- All modules are **properly aligned**, reaching a **92% in tolerance** within the model
- In red color can be seen the **skirting-boards that have not yet been installed** and a mesh present in the cloud that does not match the model
- Complete facade, 110ft², **adapted smoothly to the curve geometry** of the building
