About the project:

- Location: Madrid, Spain.
- Industry: Office building

The problem

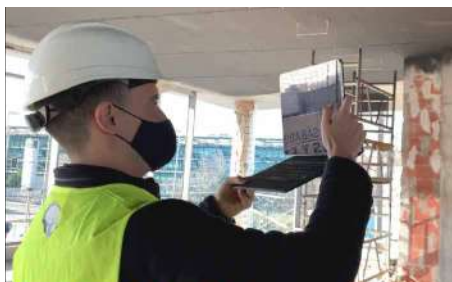
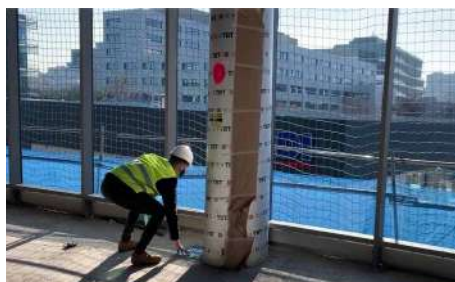
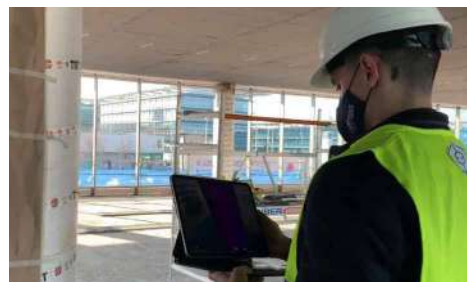
As the most suitable data capture technique for the client was through applications on an iPad, the inspection was processed with more than one point cloud against the BIM model, it showed:

- All modules are **properly aligned**, reaching a **92% in tolerance** within the model
- In red color can be seen the **skirting-boards that have not yet been installed** and a mesh present in the cloud that does not match the model
- Complete facade, 110ft², **adapted smoothly to the curve geometry** of the building
